Manhole Inspection Summary

Manhole # S41K2_002MH

Record Plat: **41K2** Node: **002** Status: **New Manhole (Not in GIS)** Insp Date: **4/8/09 12:00 AM**

Location Address: **Church ST**

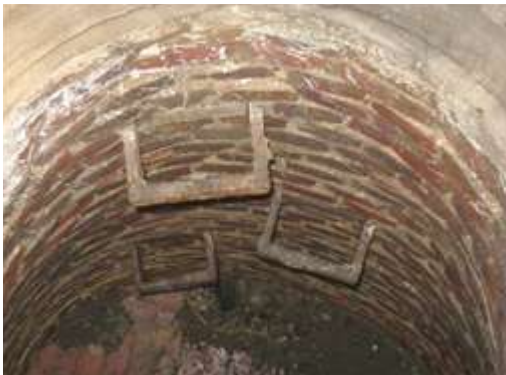
steps

Steps Count: **3** Missing: **0** ☐ Corroded

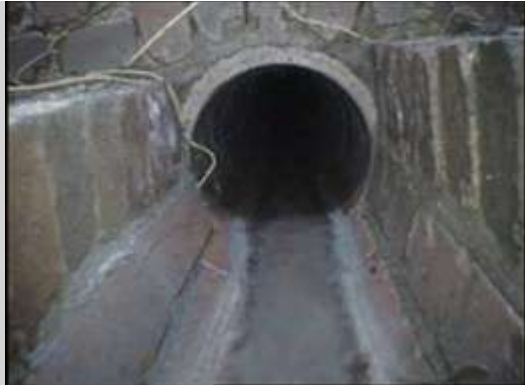
12 O'Clock Outflow

8 in. Circular Gravity Sewer
Pipe Out @ 12 O'Clock

Pipe Height: **8.4** (in.) Rod and Bar (Angled)
Pipe Material: **Clay** ☐ Pipe Lined
Invert Depth: **8.65** (ft.) Flow Characteristics: **Slow**
Deposits: ☒ None ☐ Mud ☐ Sludge ☐ Debris ☐ Grease
Silt Depth: (in.) Deposits Extent:
Infiltration: **None** Pipe Seal Cond: **Sound**

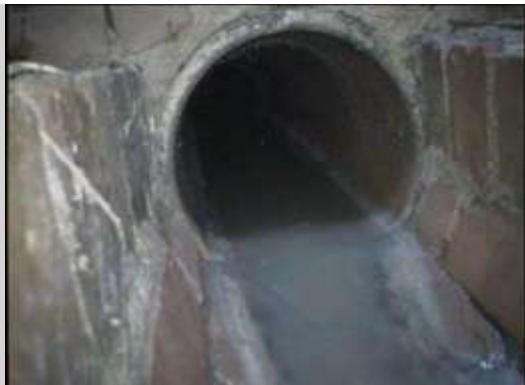
6 O'Clock Inflow

8 in. Circular Gravity Sewer
Pipe In @ 6 O'Clock

Pipe Height: **9.6** (in.) Rod and Bar (Angled)
Pipe Material: **Clay** ☐ Pipe Lined
Invert Depth: **8.50** (ft.) Flow Characteristics: **Slow**
Deposits: ☒ None ☐ Mud ☐ Sludge ☐ Debris ☐ Grease
Silt Depth: (in.) Deposits Extent:
Infiltration: **None** Pipe Seal Cond: **Sound**
